**Flood Control Project Maintenance  
Levee Inspections**  
**LMA District Cover Sheet**  
**Spring 2018 Levee Inspection Results**

**Merced Streams Group**

**Flood Control Project Maintenance  
Levee Inspections  
Unit Cover Sheet  
Spring 2018 Levee Inspection Results  
Merced Streams Group**

**Levee Inspection Report By Mile - Spring 2018**

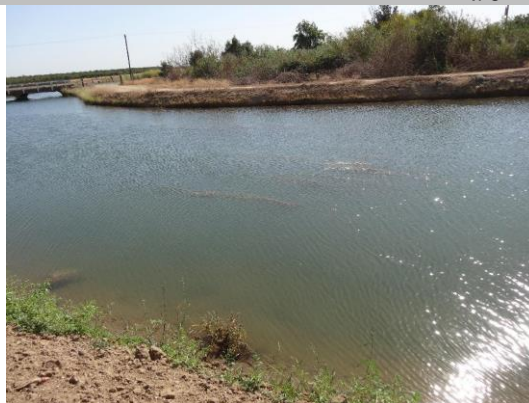
Photo 1 of 3 : UCIP\_SP\_2018\_41672\_35211.jpg

Comment Code						
Inspector Comment						
FS_ID:41672						
DS_ID:23079						
EP_NO: N/A						
Repair Type: Non-Urgent						
Crossing Status: Indicator Found						
UCIP Comments: Verify Pipe is abandoned or still intact.- may be this crossing was abandoned/removed during recent levee reconstruction.- no signs of pipe and appurtenances on waterside.- only a CM pipe riser with slide gate found on landside.						
FIELD_STRUCT_DESC: 36-inch corrugated metal irrigation pipe through the levee, 10 feet below the crown. Riser on the landside (LS). Screw gate in a 48-inch pipe well on the waterside (WS) slope. Concrete headwall and cobble spillway at the LS toe. Concrete headwall at the WS toe. [Additional Reference(s): USACE San Joaquin O&M Manual 607, June 1962, (HLM 1.32)].						
FS Date: 9/17/2013

WS view: no signs of pipe and appurtenances on levee slope and channel bank.

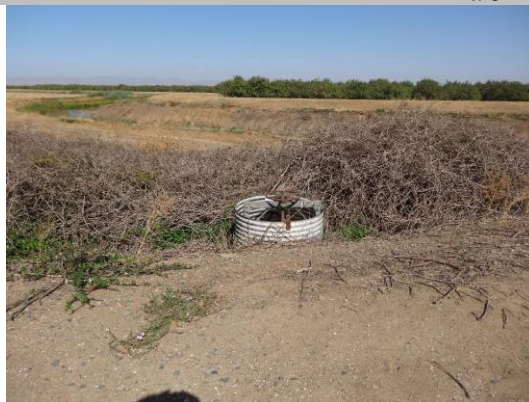
Photo 2 of 3 : UCIP\_SP\_2018\_41672\_35210.jpg

LS view: overview of CM pipe riser with slide gate. Dense vegetation on landside.

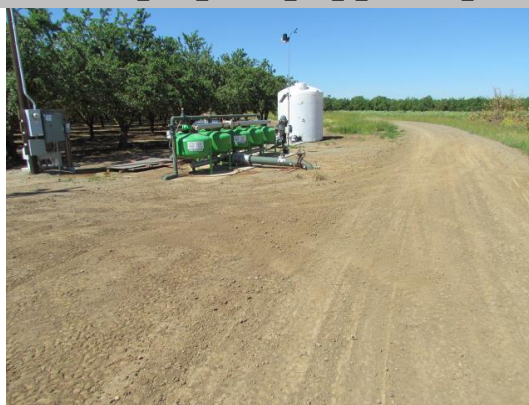
Photo 3 of 3 : SP\_2018\_NA0013\_332\_2\_20180307\_00003.jpg

No Permit for this filtration system and tank on the easement. No change since last inspection.

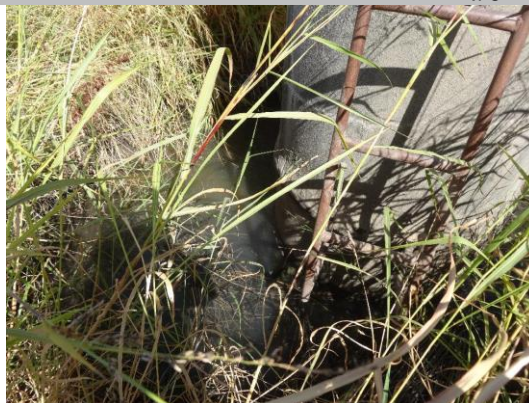
Photo 3 of 3 : UCIP\_SP\_2018\_21263\_35764.jpg

WS view: concrete standpipe with water ponding at its base.

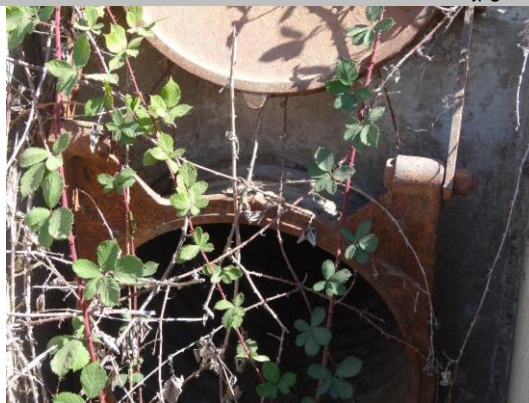
Photo 2 of 3 : UCIP\_SP\_2018\_50156\_35244.jpg

WS view: U typed concrete headwall, CM pipe, and flap gate. Flap gate was not closed. Vegetation needs to be cleared.

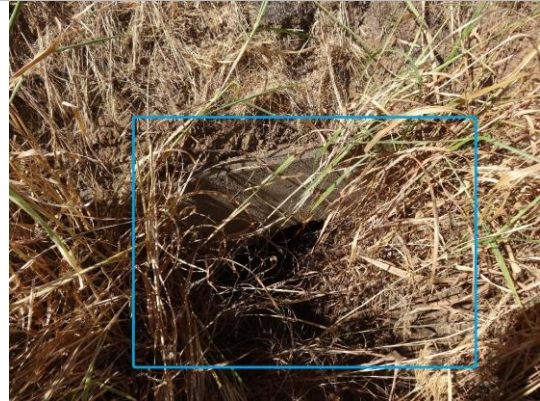
Photo 3 of 3 : UCIP\_SP\_2018\_50156\_35246.jpg

LS view: concrete headwall and CM pipe. Inlet needs cleaning.

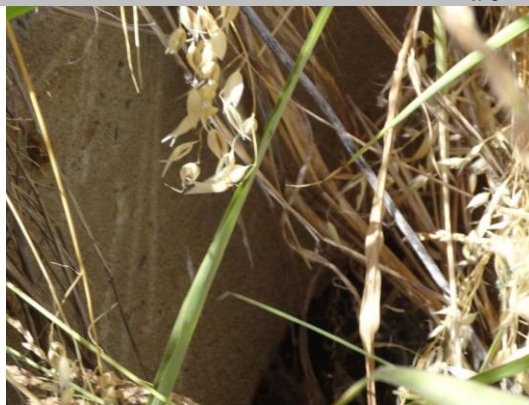
Photo 3 of 3 : UCIP\_SP\_2018\_20946\_35264.jpg

LS view: concrete headwall and CM pipe. Inlet needs cleaning.

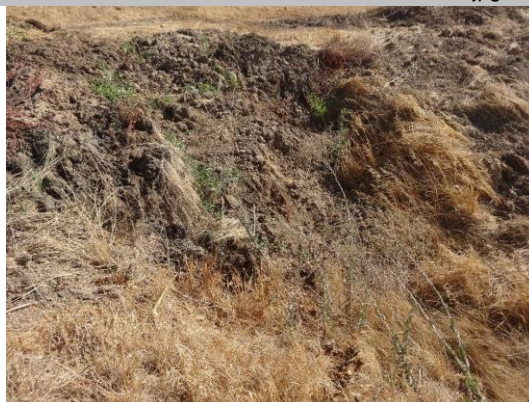
Photo 2 of 3 : UCIP\_SP\_2018\_20992\_35369.jpg

Comment Code					
Inspector Comment					
FS_ID:20992					
DS_ID:23055					
EP_NO: N/A					
Repair Type: Non-Urgent					
Crossing Status: Found					
UCIP Comments: - mud and debris from recent channel cleaning needs to be removed from spillway and outlet - pipe filled with debris, it needs cleaning.- half of intet pipe burried.					
FIELD_STRUCT_DESC: 24-inch corrugated metal gravity drainage pipe through the levee, 8 feet below the crown. Concrete headwall, flap gate, and concrete grouted cobble spillway on the waterside (WS) toe. Concrete headwall on the landside (LS) toe. [Additional Reference(s): DWR Levee Log, 2005. USACE San Joaquin O&M Manual 607, June 1962, (HLM 0.73)].					
FS Date: 9/17/2013

WS view: debris and mud deposited from the channel cleaning. It needs to be cleared from spillway and outlet structure.

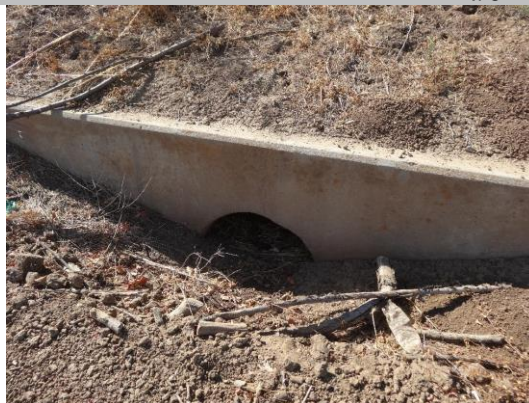
Photo 3 of 3 : UCIP\_SP\_2018\_20992\_35366.jpg

LS view: concrete headwall and CM pipe. Half of intet pipe buried.

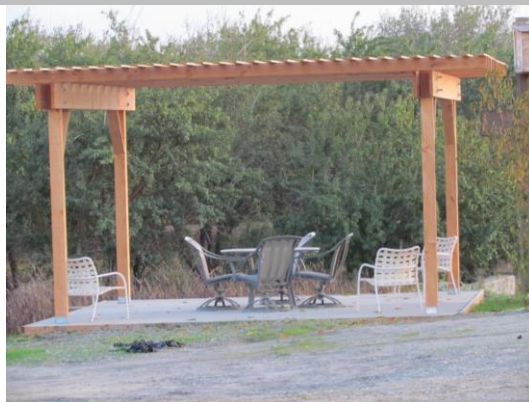
Photo 1 of 4 : SP\_2018\_NA0013\_332\_24\_20180307\_00008.jpg

Unauthorized encroachment placed on the landside shoulder and berm.

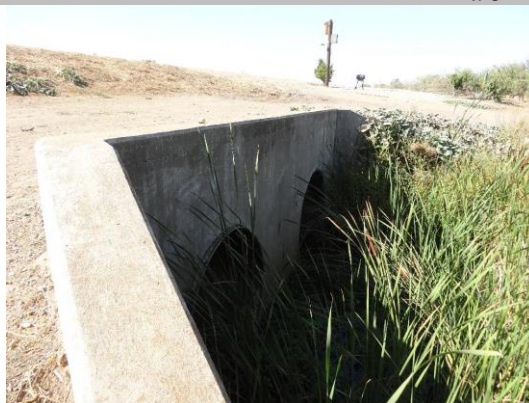
Photo 3 of 3 : UCIP\_SP\_2018\_20965\_35290.jpg

LS view: two CM pipes and U typed headwall on levee toe. Green vegetation in drainage channel.

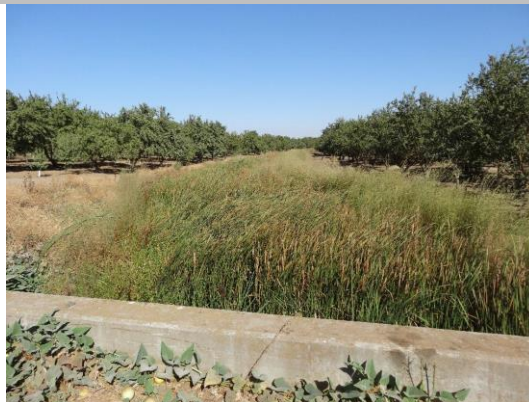
Photo 3 of 3 : UCIP\_SP\_2018\_20983\_35300.jpg

LS view: concrete headwall in drainage ditch. Dense vegetation in drainage ditch.

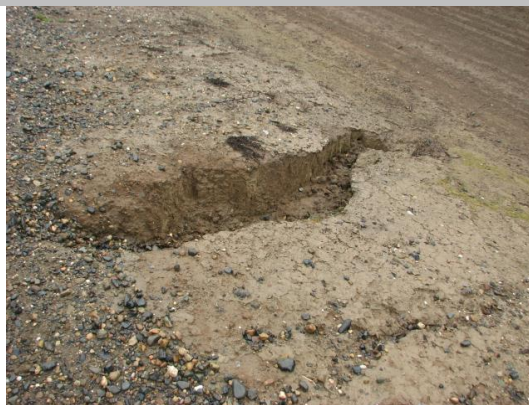
Photo 2 of 2 : SP\_2018\_NA0013\_332\_15\_20180409\_00037.jpg

Looking downstream at finger erosion on landward slope. (Spring 2018)

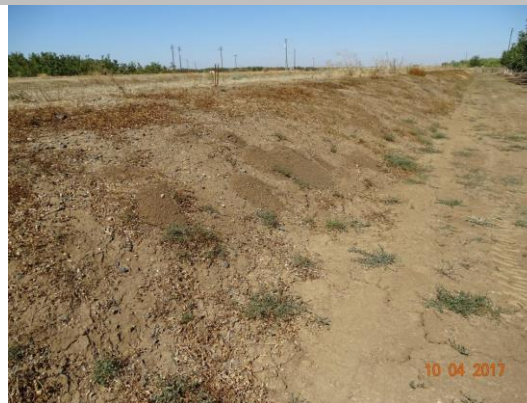
Photo 1 of 1 : SP\_2018\_NA0013\_332\_18\_20180307\_00007.jpg

Rodent activity on LS slope.

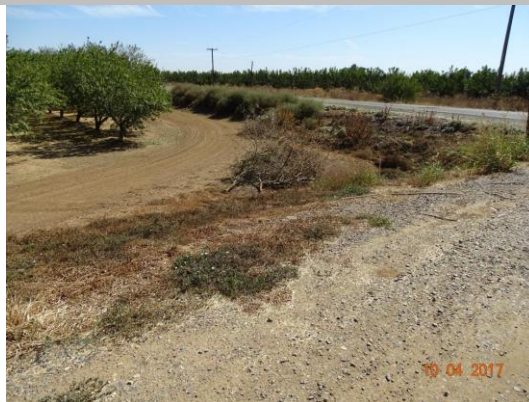
Photo 1 of 1 : SP\_2018\_NA0013\_332\_11\_20180307\_00004.jpg

Walnut tree has been cut down. Should be removed to allow access to toe area.

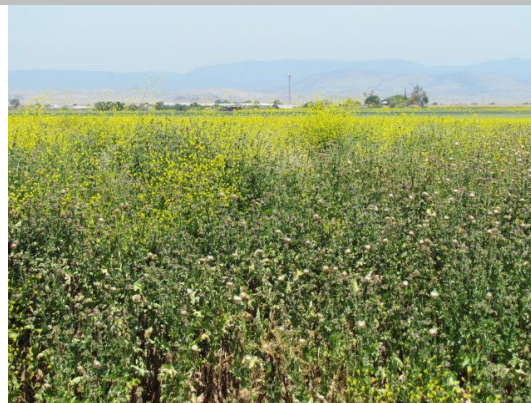
Photo 3 of 3 : SP\_2018\_NA0013\_333\_12\_20180307\_00002.jpg

Owens Creek levee mile 0.00 -1.40, unsatisfactory growth of weeds has completely taken over the levee section.(Spring 2017)

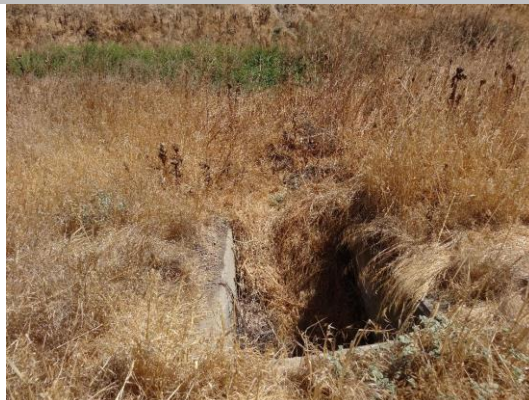
Photo 2 of 3 : UCIP\_SP\_2018\_41815\_35532.jpg

WS view: Silt needs to be removed. Vegetations needs to be cleared.

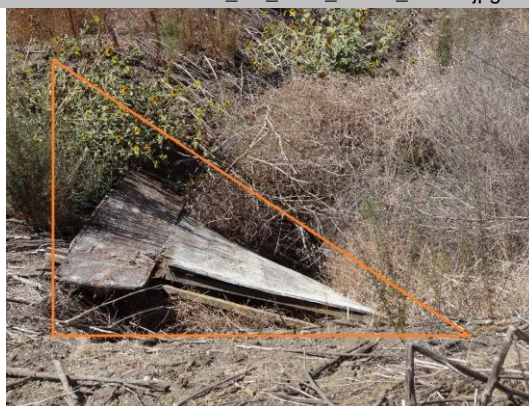
Photo 3 of 3 : UCIP\_SP\_2018\_50144\_35420.jpg

LS view: Debris dumped on inlet structure. Needs to be cleared or abandoned properly.

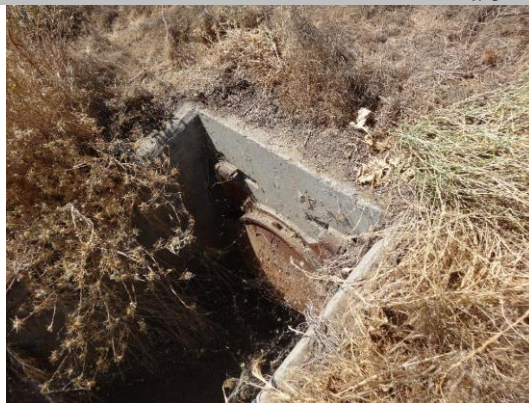
Photo 2 of 3 : UCIP\_SP\_2018\_50149\_35534.jpg

WS view: U typed concrete headwall, CM pipe, and flap gate. Vegetation needs to be cleared.

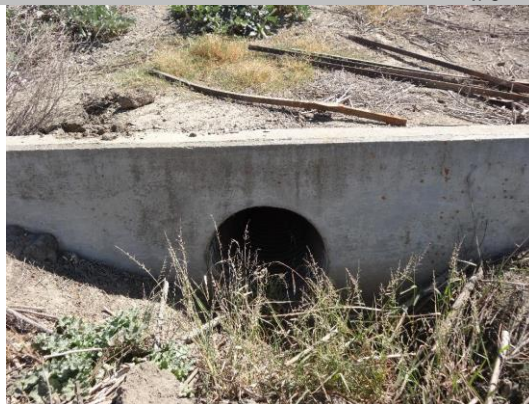
Photo 3 of 3 : UCIP\_SP\_2018\_50149\_35537.jpg

LS view: concrete headwall and CM pipe. Inlet needs clearing.

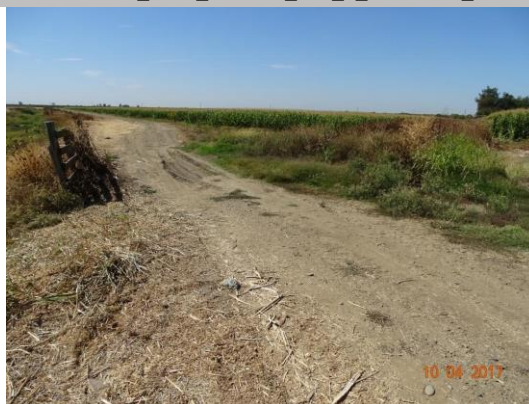
Photo 1 of 1 : SP\_2018\_NA0013\_333\_9\_20180307\_00001.jpg

Repair rutted crossing over storm drain. Restore grade and add gravel.

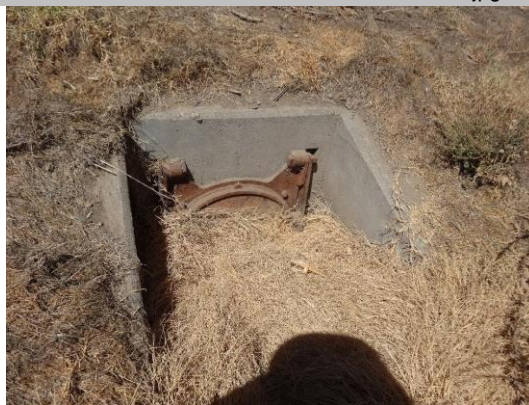
Photo 2 of 3 : UCIP\_SP\_2018\_50152\_35543.jpg

WS view: U typed concrete headwall, CM pipe, and flap gate. Vegetation needs to be cleared.

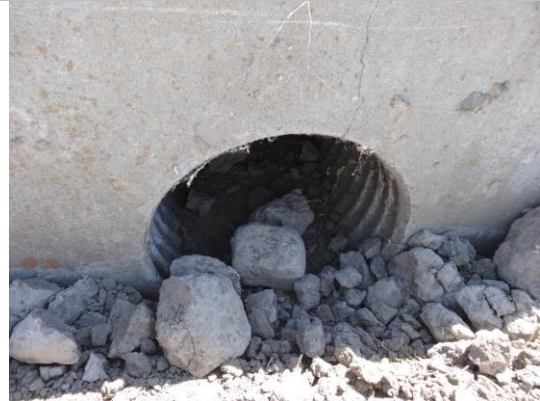
Photo 3 of 3 : UCIP\_SP\_2018\_21063\_35500.jpg

LS view: closer view of CM pipe. Inlet needs cleaning & clearing.

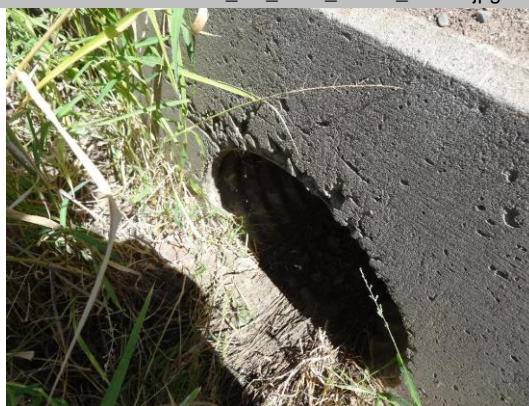
Photo 3 of 3 : UCIP\_SP\_2018\_21064\_35504.jpg

LS view: concrete headwall and CM pipe. Inlet needs clearing.

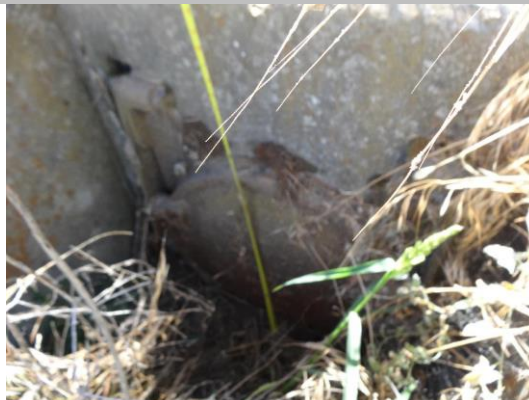
Photo 2 of 3 : UCIP\_SP\_2018\_42991\_35750.jpg

WS view: U typed concrete headwall, CM pipe, and flap gate. Vegetation and silt need to be cleared.

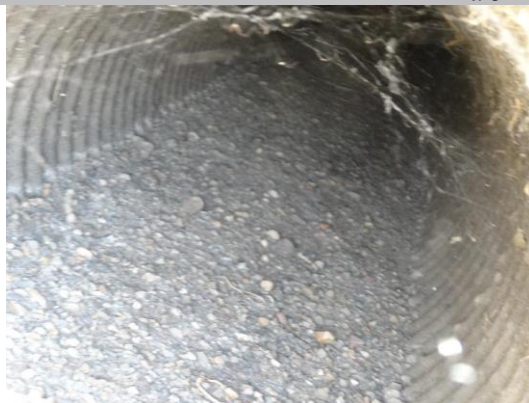
Photo 3 of 3 : UCIP\_SP\_2018\_50146\_35746.jpg

LS view: inside view of CM pipe. Inlet pipe needs clearing.

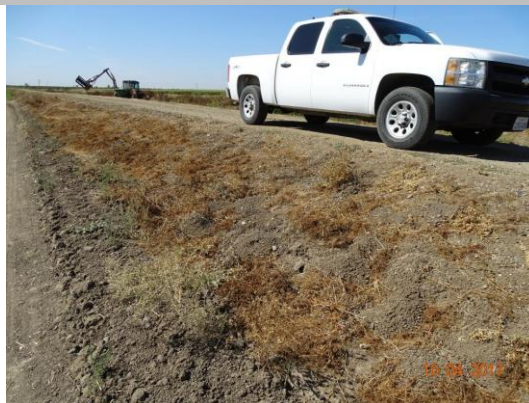
Photo 1 of 1 : SP\_2018\_NA0013\_334\_10\_20180307\_00001.jpg

Numerous rodent holes on LS slope.

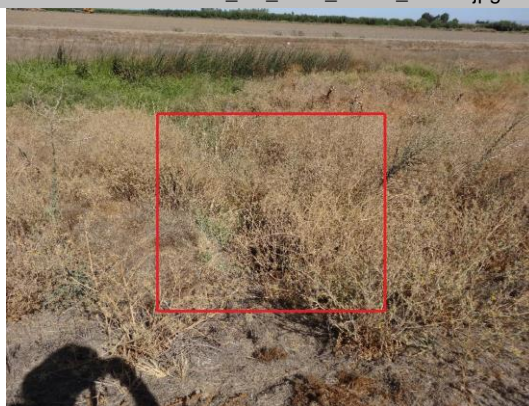
Photo 1 of 3 : UCIP\_SP\_2018\_50154\_35608.jpg

WS view: Dense vegetation on levee slope and spillway.

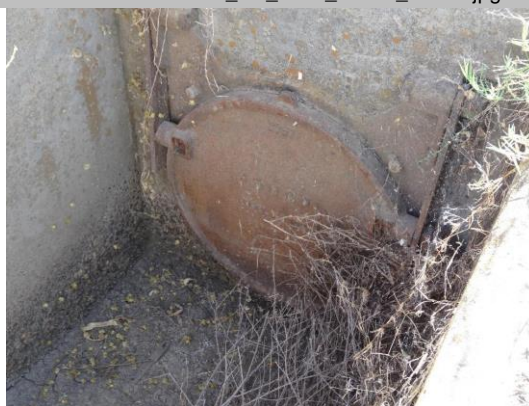
Photo 3 of 3 : UCIP\_SP\_2018\_50154\_35606.jpg

WS view: CM pipe and flap gate. Vegetation needs to be cleared.

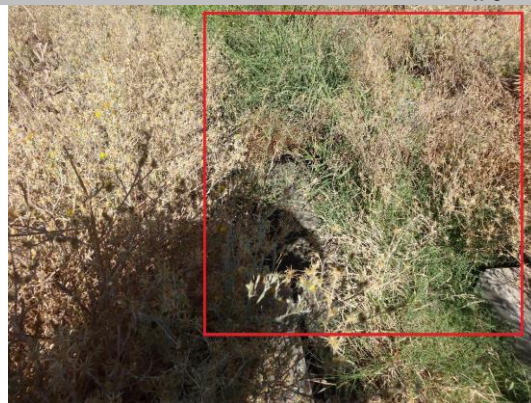
Photo 1 of 3 : UCIP\_SP\_2018\_50148\_35613.jpg

WS view: Dense vegetation on levee slope and spillway.

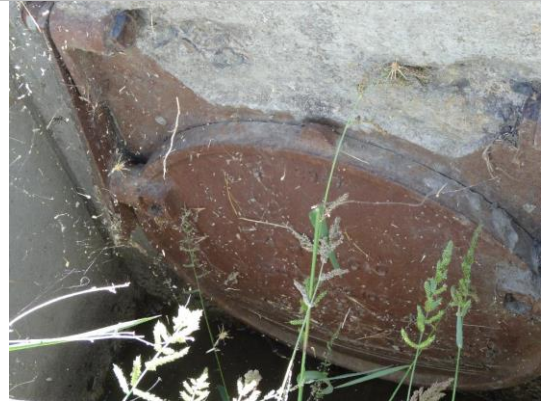
Photo 3 of 3 : UCIP\_SP\_2018\_50155\_35640.jpg

WS view: CM pipe and flap gate. Vegetation needs to be cleared.

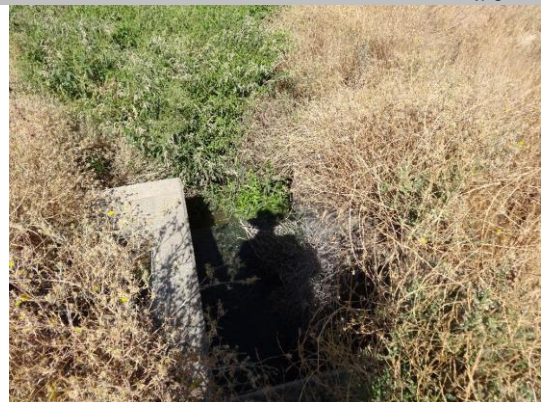
Photo 1 of 3 : UCIP\_SP\_2018\_21126\_35652.jpg

WS view: concrete spillway and channel on waterside. Dense vegetation on levee slope and spillway.

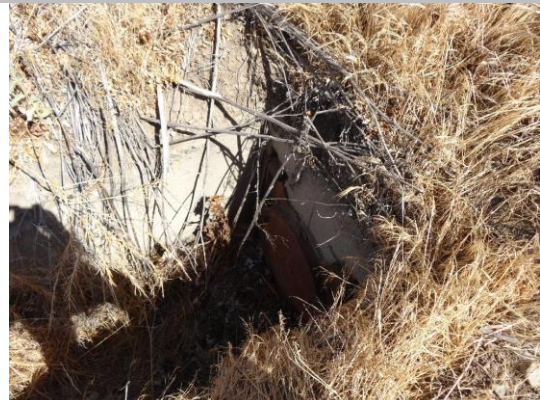
Photo 1 of 3 : UCIP\_SP\_2018\_21210\_35709.jpg

WS view: concrete spillway and channel on waterside. Dense vegetation on levee slope and spillway.
